Phase 2: Recommissioning and MOT Preparation

With your E36 now fitted with a smooth-running replacement engine, we move into Phase 2 of the build. Recommissioning the car for road use, starting with the key requirements to pass the MOT.

There are five main areas of focus: **rust repairs**, **lighting**, **gearbox leak**, **starter** and **cosmetic damage**.

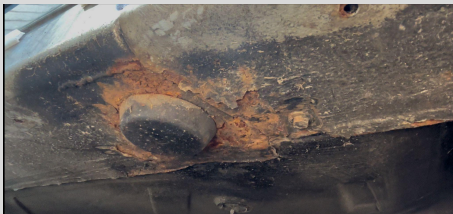
- **Nearside Front:**

Appears similar in condition to offside front but performed well under load. The metal is solid and has been previously repaired to a good standard. (See attached photo.)

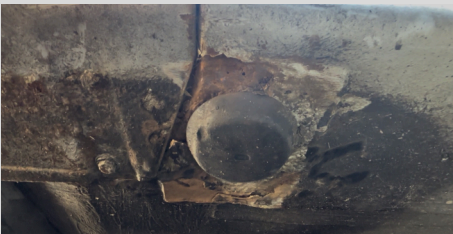
- **Offside Front:**

At first glance, this looked fine with the original rubber still in place. However with a poke with a screwdriver, we heard the telltale crunch of soft rusted metal. A quick inspection confirmed soft metal beneath a patch is required here to pass MOT. (See attached photo.)

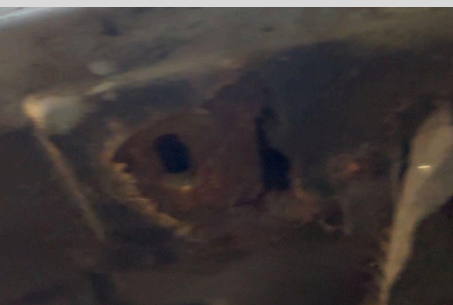
- **Nearside Rear:**

This point is failing. There's a 5cm hole/crack next to where the rubber should be and it's missing. (See photo.) We did not attempt to lift from here. The rust has formed due to a previous patch being placed over existing corrosion, leading to rust from the inside out. Full removal and replacement of internal structure is required.

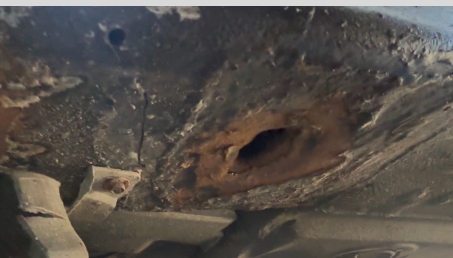
- **Offside Rear:**

Similar to the nearside rear. The rubber is missing, this has led to internal corrosion, I will supply new rubbers as I have a few spare. Internal structure is solid, and requires cleaning up.

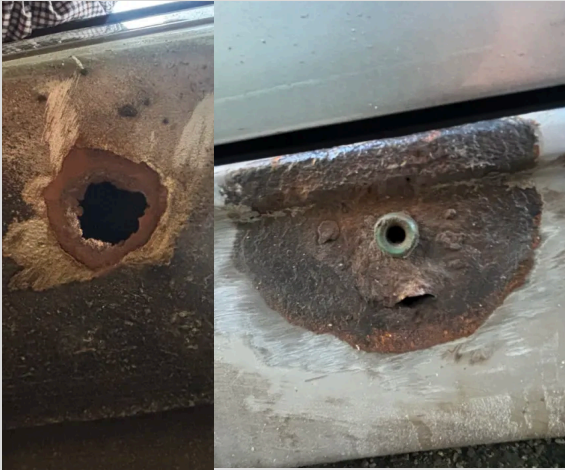
Side Sills

- **Nearside Sill:**
In good condition, small pin holes of rust which we will spot weld and reseal
- **Offside Sill:**
Two holes present. One is just below the driver's door, where we previously noted bubbling. On inspection, the area is heavily rusted inside and soft. It will need cutting out and replacing with a 5x10cm patch, shaped around the door crease. (See 2 photos.)

Please note that following the sill repairs, the areas will be treated with red oxide rust-proofing paint and finished with a black underseal. As a result, the lower section of the sills beneath the silver M Sport side skirts will be black rather than silver. However, this will not be visible once the side skirts are refitted, and the treatment will provide long-term protection against corrosion

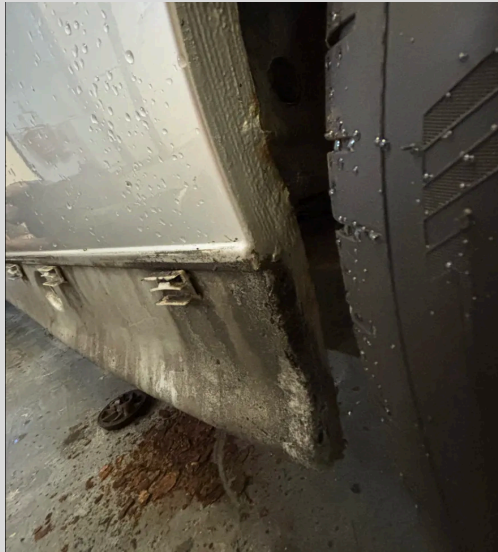
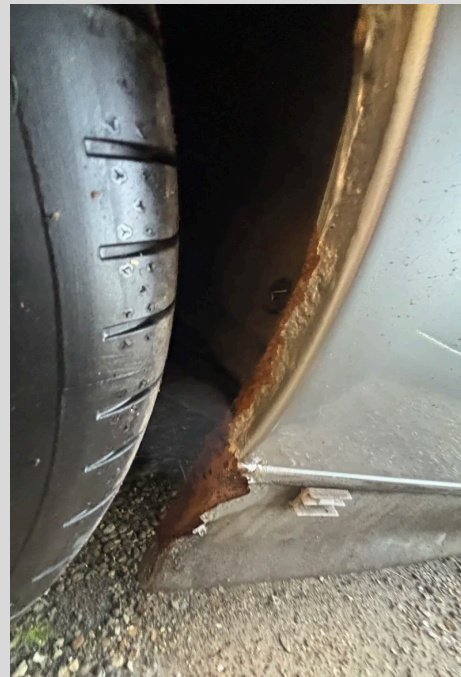
Wheel Arches:

Both arches show signs of surface rust but are solid. They require grinding down, spot welding and treatment

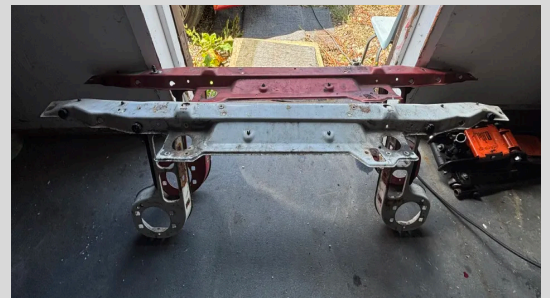
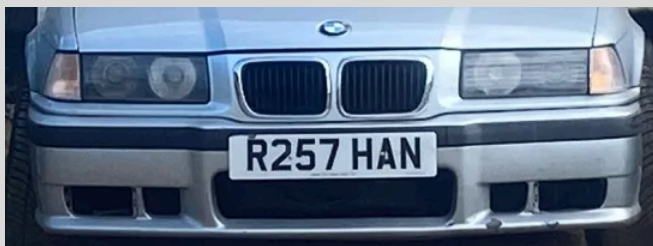
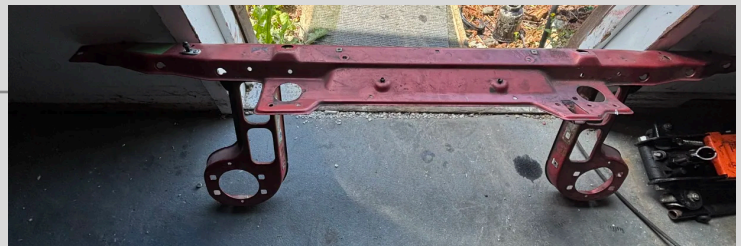
- **Slam Panel:** £50 Fitted
Needs replacement. (Photo above of 2 options, one is white and corroded and one is red with no rust, let me know which one you prefer)
- **Nose Cone:** £120 Fitted
Also needs replacing – the current unit is damaged. I have the correct one without headlight washers on my car. photo of it on my own E36 here (Photo attached.)
