Report and Health Check

BMW E34 520i

Declan Lee Motorsport
Unit 3 Fen Place Farm
East Street
Turners Hill
West Sussex
RH104QA

Report Date:
March 21st 2026

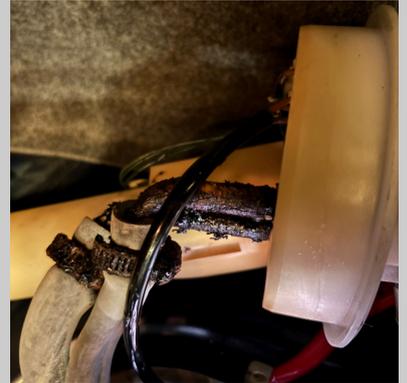
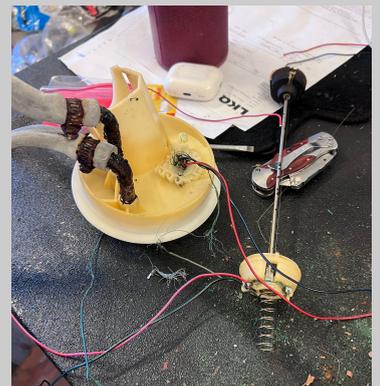
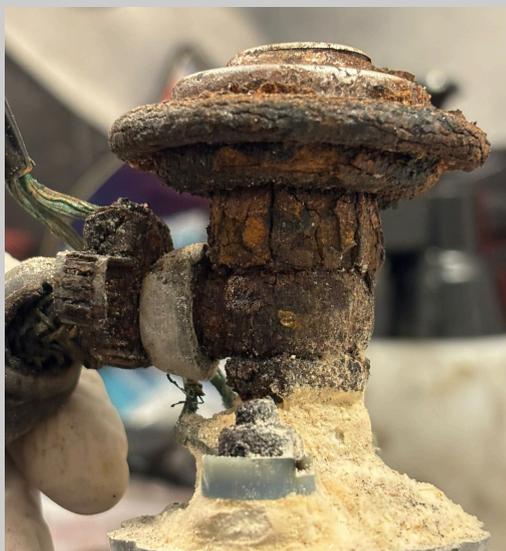
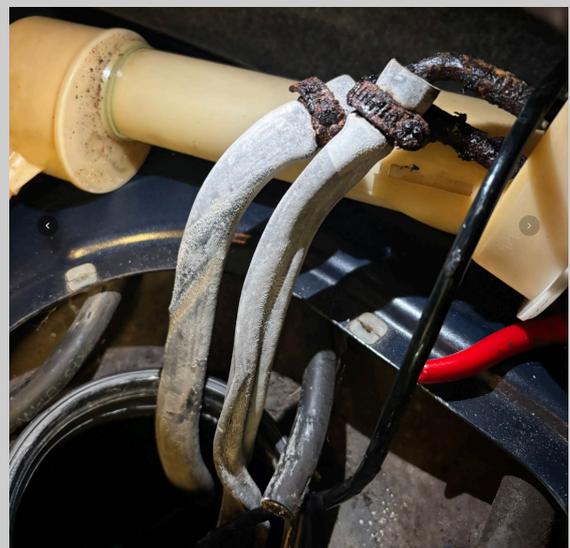
Initial diagnostic procedures identified a fault within the fuel system, specifically a lack of fuel delivery to the fuel rail. Further investigation confirmed that the fuel pump was not functioning.

Upon removal of the fuel sender unit, we found the internal condition to be significantly deteriorated; The pump itself was heavily corroded, internal rubber hoses had perished and was breaking apart, and the wiring supplying the pump was brittle, corroded, and partially split.

In addition the fuel system had been clogged by old fuel which had degraded into a thick, varnish like substance. To resolve this, We replaced the fuel filter and all fuel lines were flushed through with compressed air to remove any contamination.

Due to the rarity of replacement sender units, particularly those incorporating the fuel level sensor, we carried out a careful refurbishment of the original component. This involved dismantling the unit, cleaning all electrical contacts, removing the damaged wiring, and replacing it with new sections which were then professionally soldered back into place. We do this to increase the fuel gauge accuracy.

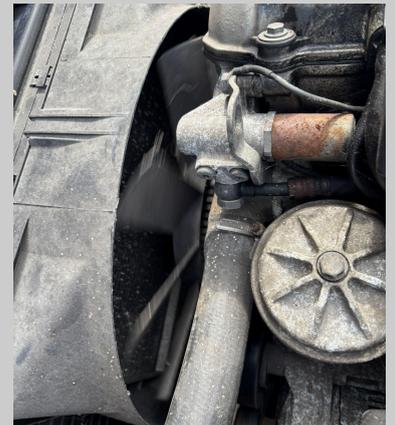
We ran our OBD1 scanner to the D100 20 pin connector to run a digital diagnostic, meaning we cleared old fault codes and then scanned for fault codes that were persistent. There was a repeating error for a faulty cam position sensor, which means it still works as the car wouldn't run right without it, however it is reading an occasional error which may lead to a non-start situation in the future. This may also be caused by the starter motor which occasionally when starting the car does not engage correctly, if this happens the issue will sound obvious, stop cranking and try again. This is a sign of a new starter motor needing replacement in the future.

Otherwise the engine runs smoothly with no signs of abnormal mechanical noise, and there are currently no major oil leaks with a slight weep coming from the front of the rocker cover, not excessive and not bad enough to leak down the side of the engine block or to be of current concern.

Given the length of time the vehicle has been stationary, an oil and filter change is strongly recommended as a priority.

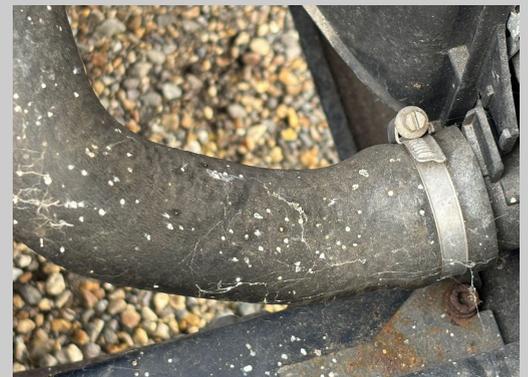
The cooling system is functional, and the coolant hoses are currently holding pressure. However, they are beginning to show signs of age-related wear, including surface cracking and dryness. While not immediately failing, these should be considered for replacement as preventative maintenance.

We have found that M50 Engines like the one found in your E34, the viscous fan clutch can become weak, meaning in the case of your E34 you could stop the fan with your hands, whereas it should normally try and take a finger if you did that to a functioning viscous fan. This is an early sign of failure and may lead to cooling inefficiency, particularly in traffic or during extended idling.

When driving a car that has sat for a long period of time it is extremely important to keep an eye on the gauges. Since the cooling system has not seen a heat cycle in so many years, components within the engine such as the thermostat which relies on temperature to operate can become stuck, this can happen at any time. If you find yourself with the temperature in the red, switch the engine off immediately, and coast to a stop. This situation can be avoided with a new thermostat, waterpump and viscous fan clutch, Replacement is recommended, but not required.

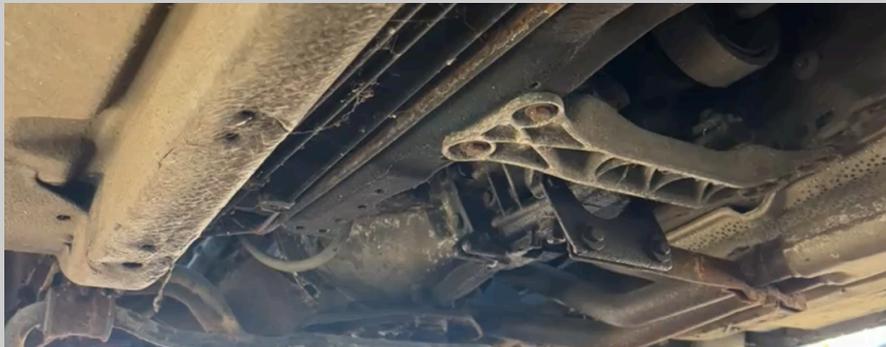
The drivetrain is generally in good condition for a vehicle of this age. The rear differential and propshaft both show surface corrosion, which is typical, but there are no immediate concerns regarding their structural integrity or operation.

As the vehicle has been stationary for an extended period, we recommend replacing both the gearbox and differential oils. This is a preventative measure to ensure proper lubrication and to protect internal components as the vehicle returns to regular use.

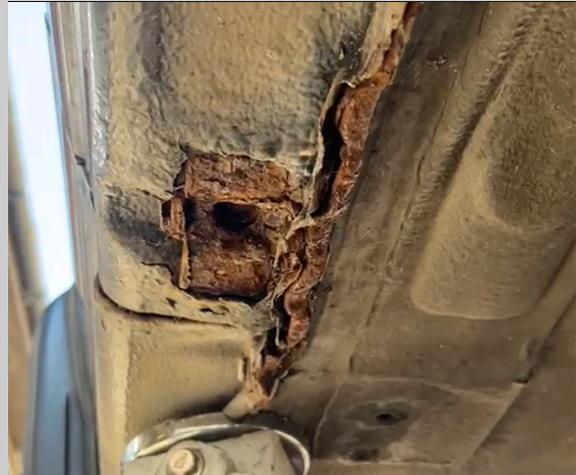
The sills are structurally intact, although the seam lines have been distorted in places, most likely due to incorrect jacking in the past. The rear jacking points show surface corrosion and would benefit from cleaning and protective treatment.

More notably, the front jacking points are heavily corroded and will require welding. The full extent of this corrosion cannot be confirmed until the affected areas are cut back.

This means that it will be very unlikely it will pass a MOT in its current condition.

Overall, the main issue here is the rust to the jacking points, as there is a possibility it will not pass an MOT, there are two options to repair, now the rust is something that can only be quoted on our hourly welding rate which is £80 Per Hour. The full extent of the hours required can only be diagnosed once we start cutting away the rust, so the hours we quote are subject to change.

A simple metal patch can be done here, however it won't be possible to weld to the inner structure, which means the car can't be jacked up on this area. This solution would pass an MOT and take 3 hours of welding.

What we would recommend is the rust be totally cut out, a thick metal plate fitted and repair the inner sill which as you can see from the above photo is bent flat and rusting. This would allow for the OEM rubber jacking point to fit into the hole you can see in the middle of the jacking point. This solution would allow the car to be jacked up on this area as intended and take 4-5 hours of welding.

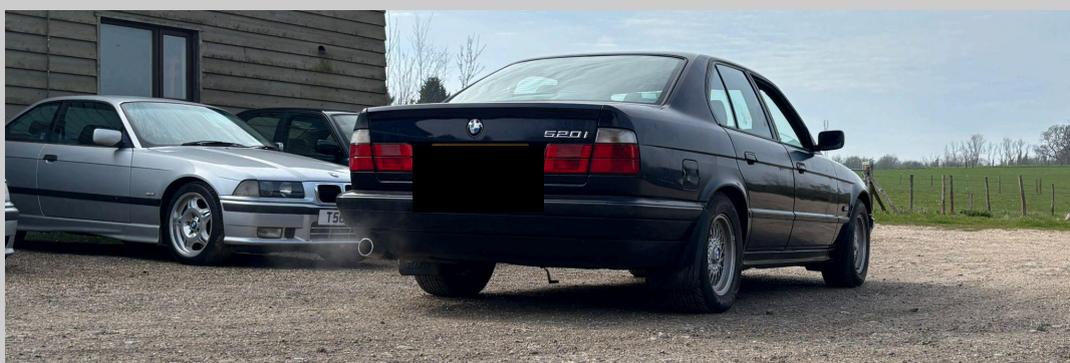
The exhaust system also shows signs of corrosion, and while currently intact, it may require repair or replacement in the future. Currently no leaks and sounds just as good when it was a running and driving car all those years ago.

The fuel lines are in usable condition but would benefit from a protective coating to prevent further degradation.
