Report and Health Check

BMW E24 635CSi

Declan Lee Motorsport
Unit 3 Fen Place Farm
East Street
Turners Hill
West Sussex
RH104QA

Report Date:
November 10th 2025

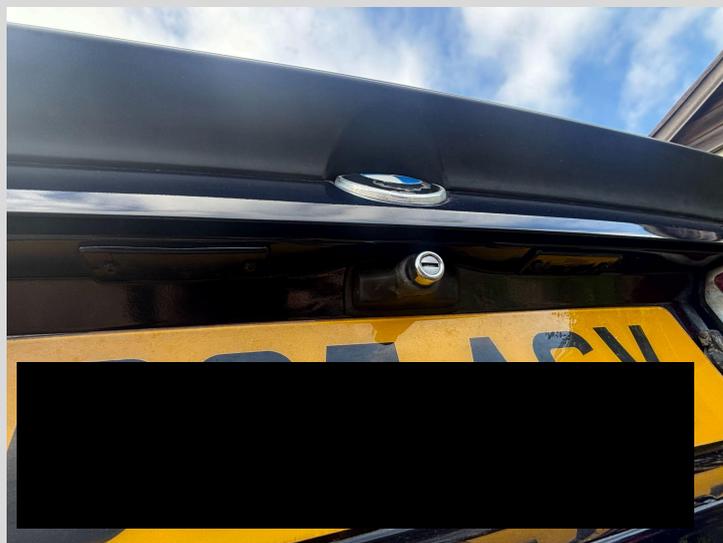
Rear Registration Plate Lights Painted Over

The car appears to have undergone a respray at some point in its life, and while the finish overall presents very nicely with a good shine and even colour. There are a few telltale signs that the job wasn't carried out to a fully professional standard. In particular, several areas have not been properly masked off, resulting in some noticeable overspray. One example of this is around the rear number plate lights although they are functioning correctly, the clear lenses have unfortunately been painted over during the respray, preventing the light from shining through as intended. A simple cleanup or replacement of these lenses would help tidy up the overall appearance and restore proper illumination.

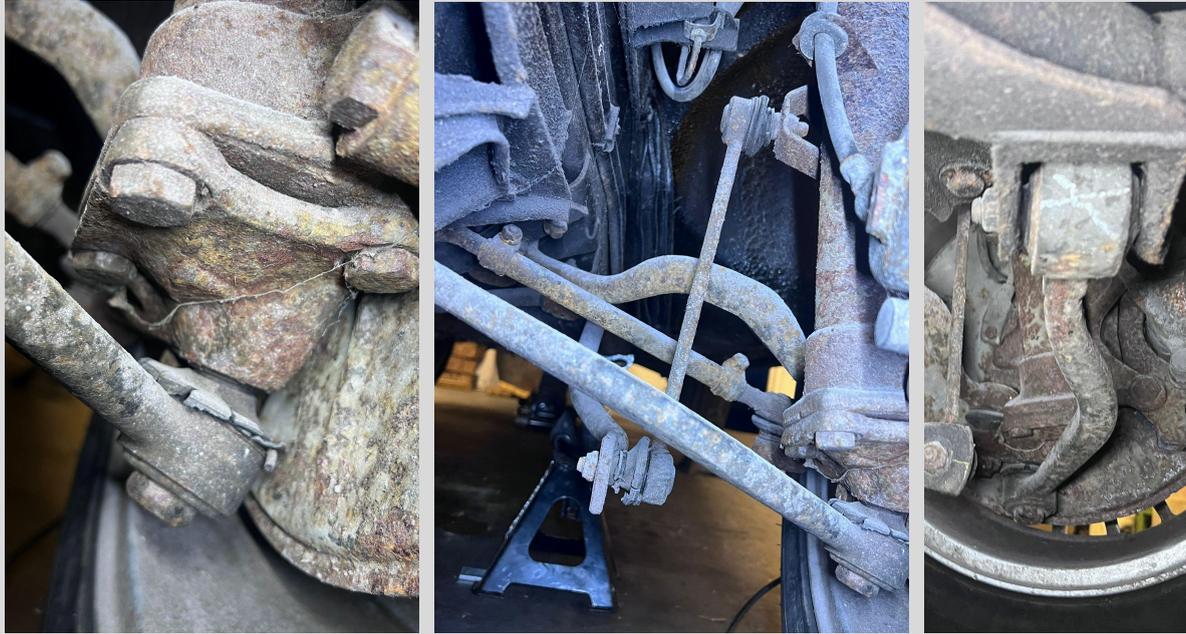
Nearside front lower arm and both drop links / dust boot:

The bushing and rubber boot that keeps grease has perished causing a lot of resistance and is a contributing factor to why the power steering is having to work overtime. It is possible to push out the bushing and replace but we would advise replacing the whole arm as they are still available from BMW and much less labour is involved, only 1 hour compared to 2 hours per arm to replace the ball joint and bushing.

The Offside arm is in much better condition, and doesn't require replacement. Both drop links as pictured in the middle photo are perished and require replacement

If we replace this suspension arm or any component within the suspension system. We would highly recommend that the vehicle undergoes a full wheel alignment afterwards. This is because removing or replacing suspension parts can alter the geometry of the wheels, affecting angles such as camber, caster, and toe, even slightly we know that in our line of work every degree of caster and tow even corner weighting is vital to lap times and overall road feel.

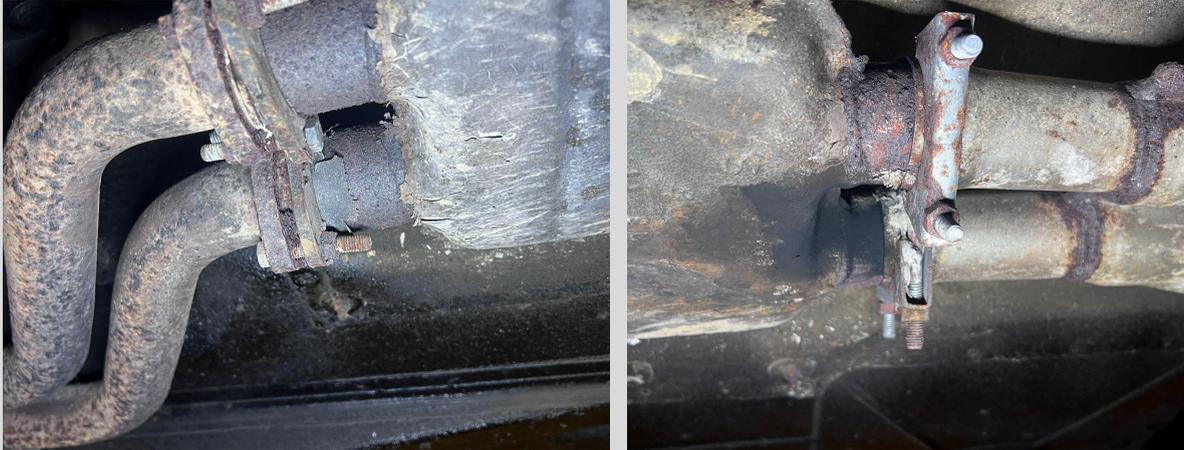
Blow in exhaust:

The exhaust is blowing in the midpipe, not excessively but definitely noticeable. With a small blow like this, it may be a simple fix with exhaust paste. If the issue persisted we would remove the rusty bolts which are corroded and bent and replace all these nuts, bolts and the inner exhaust gasket.

Roughly 2 hours labour.

This is the cheapest and least labour intensive option with your current exhaust without replacing exhaust sections, despite now enticing the Supersprint exhaust catalog can be.

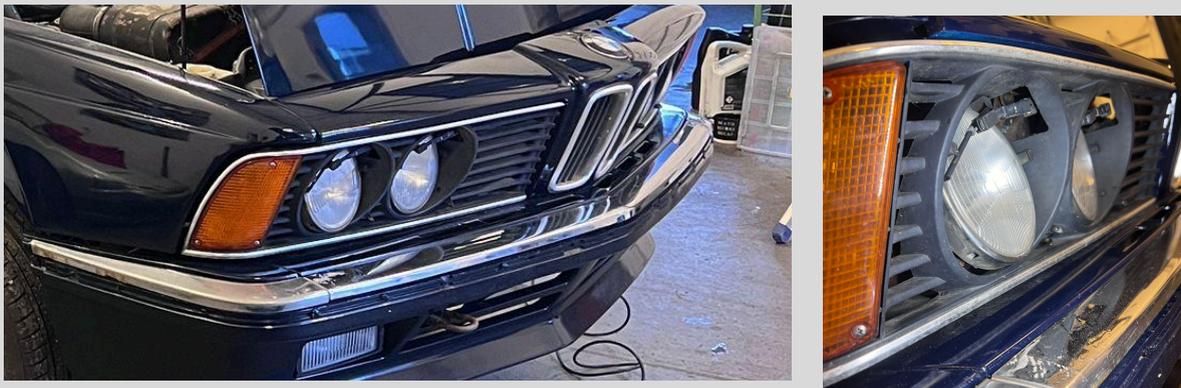
Indicators:

The Indicators have little gaskets to prevent the ingress of water, however over time as you can imagine these gaskets fail and a small amount of water can cause the bulbs and connectors to corrode.

Bulbs are cheap to replace and much cheaper than replacing the indicator gasket. We have replaced these bulbs and cleaned out the connectors on each side for you but be advised that the damp within the light will only cause the same issue for you in time.

The indicators are now working as intended.

Our advice, unlike most BMW drivers. Indicate often, using them dries out the light.

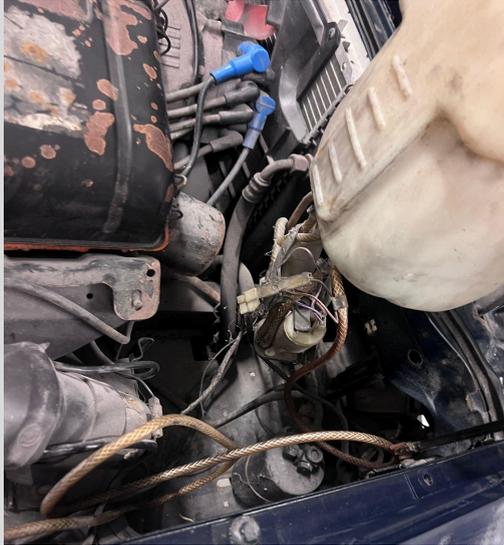
Washer fluid / washer fluid not delivering water:

The washer jets have been replaced in the past. Its been replaced with cheap hose not cut to length and a spiderweb of wires and hoses.

Ideally it needs to be reverted back to original, and tidied up back to the factory locations for the washer jets on the bonnet and jets on the headlights.

It's worth noting that only the bonnet washer jets need to work for the MOT
1-2 hours labour estimated

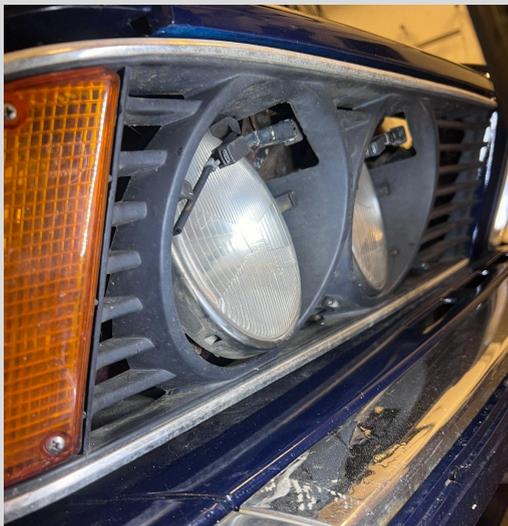
Offside Headlight Aim:

As you can see from this picture the outer headlight is facing the sky.

The adjuster unfortunately is broken, most replacement parts have the same issue they have corroded adjusters and are a costly replacement.

We've developed a method to properly aim these quad headlights. We first trialled it on an E30, where the adjuster was corroded and unusable. The process involves setting the light in the correct position and then setting them to secure the aim in place. Once it's set, it remains fixed, ensuring consistent and accurate headlight alignment, this can take a fair bit of time.
1-2 hours estimated

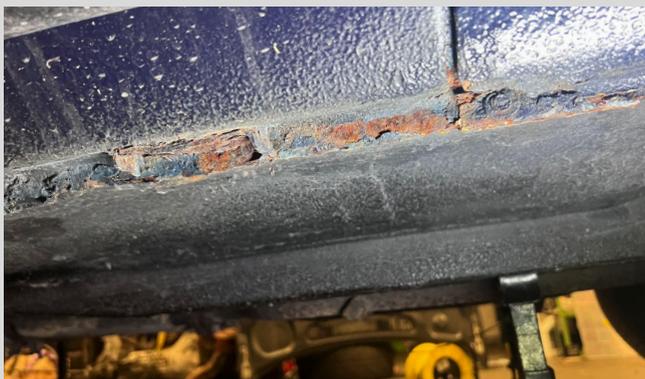
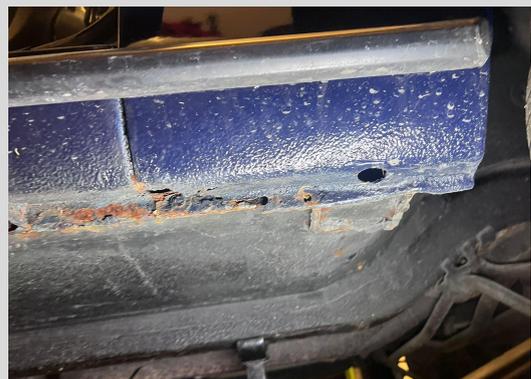
The wheel arch covers and front wings are starting to develop rust but nothing of concern currently and just need a light sand and treatment before it worsens.

Above this is the offside outer sill, its flaky with rust, but its only surface rust.

There are signs it has been painted over in the past which will only accelerate this issue. It should be wire brushed, painted with anti rust oxide paint and finished with underseal.

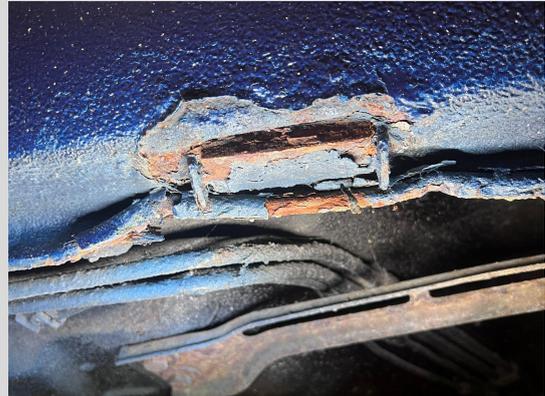
Three of of four jacking points are in good condition its only the nearside rear where the Corrosion has started to take hold.

In this photo the jacking point should be straight but you can see its bent and brown with rust. It's not an MOT fail but something To keep your eye on.

We would advice to not use this jacking point to lift the car until it has been cut out and a new jacking structure be added.

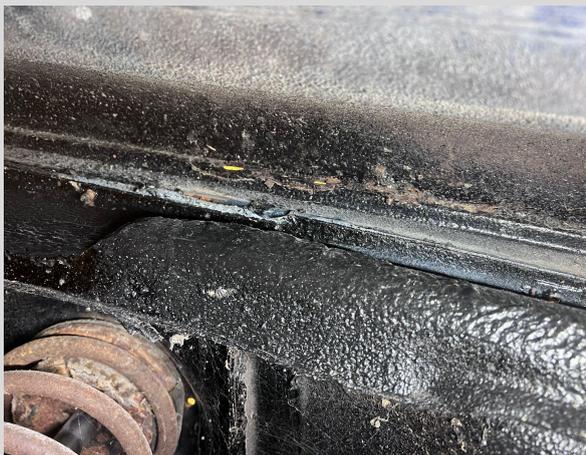
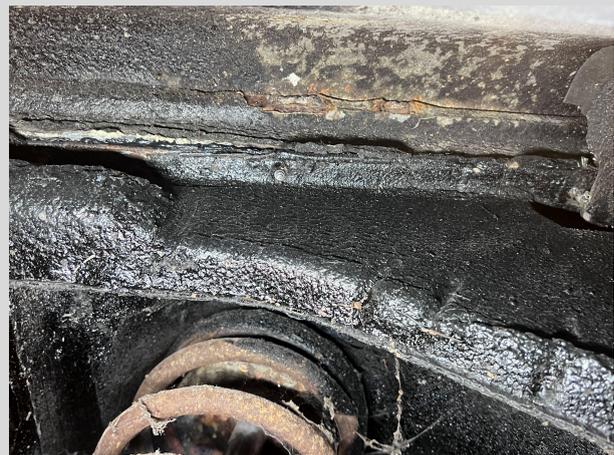
Below are photos that show signs of a good repair and underseal despite the overspray on the coil spring. The welding quality lacks neatness but is holding strong. The thick layer of underseal makes it hard to spot corrosion.

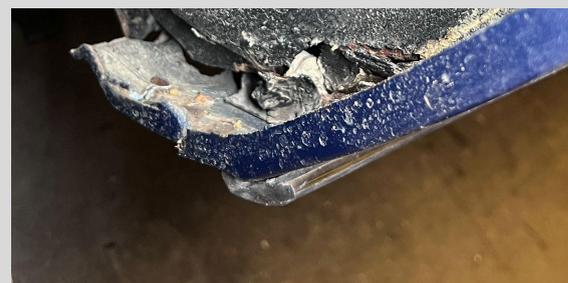
This is a photo on the right taken from the front wheel arch.

It shows rust building up on the inner sill out of sight, only small now but should be addressed before it goes into areas that require cutting the outer sill to access.

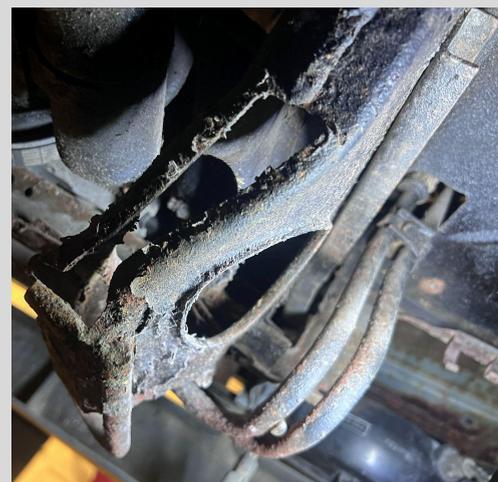
It's also worth mentioning the offside front towing point is bent and rusting where someone bent it a long time ago.

Still strong but best to use the nearside towing eye should the car need to be pulled.

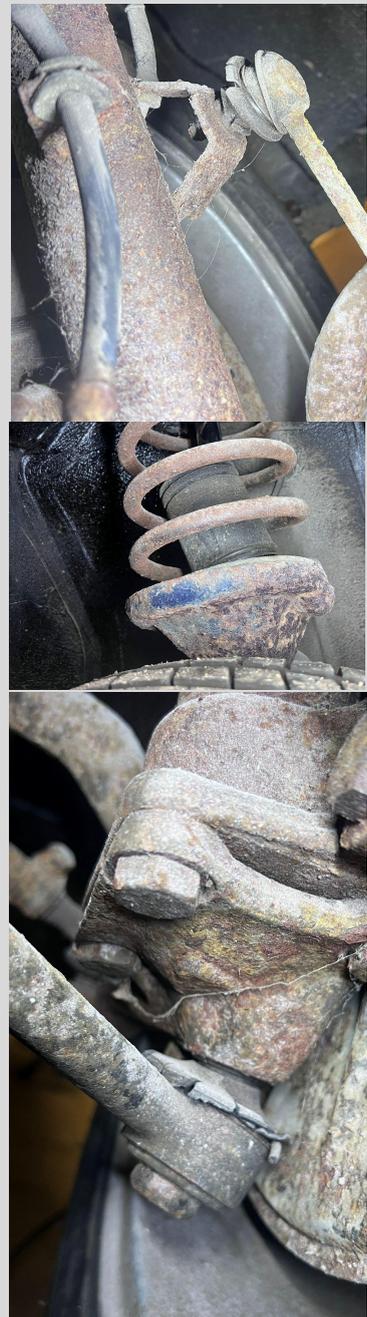
Both front shock absorbers are missing their dust boots which would be an MOT advisory

currently there is no leaks but the dust boot should be replaced to prevent the ingress of dirt.

Also there's lots of blue overspray on the suspension.

Offside front wheel bearing is making a slight noise
There is minimal play, nothing to worry about for now.

Overall the suspension is in good condition with no noises or knocks, the main area of concern is the nearside front lower arm and both front Anti roll bar droplinks.

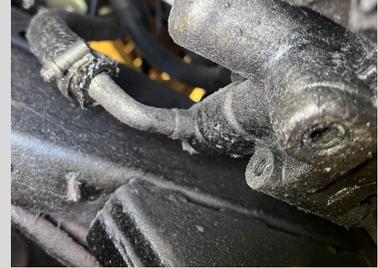
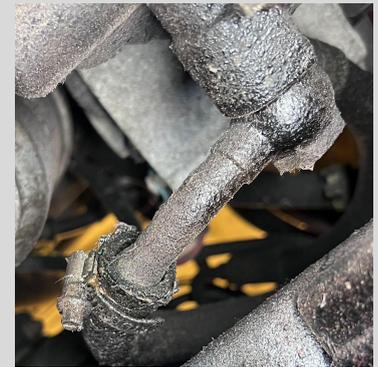
Photo of leaking line to the right.

The lines are weeping so you should keep an eye on the fluid level. This small weep is coming from the lower hose. Unfortunately this is common, but the hoses are no longer available online or BMW main dealer. We have had them custom made by a company in Italy for an E36, they can be expensive around £90 for the lower hose.

This is an option on your car but for now we would advise just keeping an eye on the power steering fluid level and keeping it topped up with PSF or ATF.

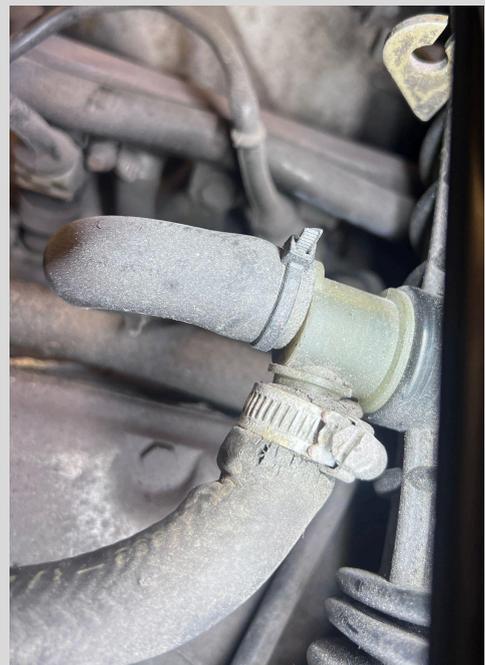
Firstly the engine is running slightly rough. Not how the M30 B35 should sound. These engines should sound like a sewing machine when everything is happy in the engine bay. There are many factors to making These M30's run right. We tested the MAF First, it's working very well. Which is great news when these cost over £450 now from BMW so that's a win! There are numerous vacuum leaks on your M30 Engine due to the vacuum lines cracking and being perished due to their age. As you can see from this photo to the right.

Overall we would recommend a smoke test be carried out to diagnose and locate the damaged vacuum lines. Its hard to quote labour as it is dependent on how many vacuum leaks we find.

This would be a relatively easy fix to get the M30B35 running like a sewing machine. Roughly 3 hours to find and fix these leaks

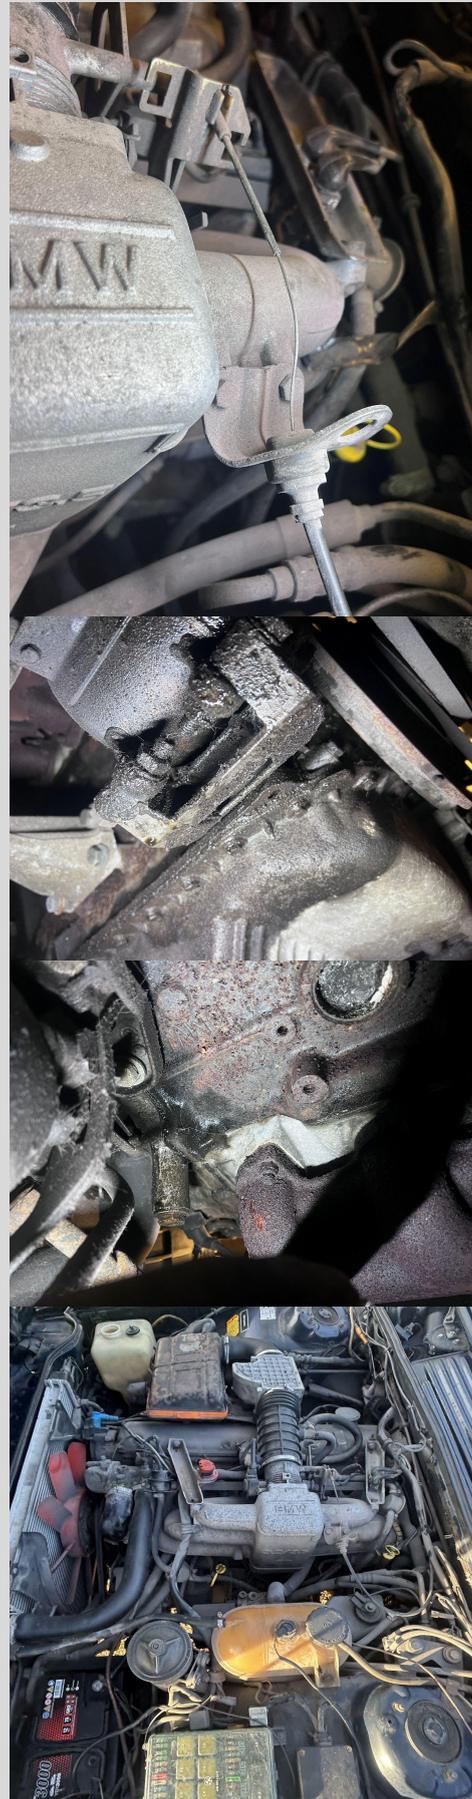
Then I would like to draw your attention to the slack in the throttle cable, this is due to it being stretched which happens over time, they can be adjusted however its ceased and the cable should be replaced.

Is readily available from BMW or Ebay. This slack means that when you initially touch the throttle pedal nothing will happen as it first pulls the slack in the cable tight then engages the throttle body. You may have noticed this when driving. The car takes a moment to rev up with having this play in the throttle cable.

There is a weep of oil coming from the rocker cover gasket. You can still get these gaskets from BMW and are easy to replace. Worth doing this to avoid covering the side of the block in oil. It's hard to capture this on a photo as it's happening around the front of the engine. But the photo on the right does show it slightly. There is also a leak from the timing chain tensioner, seems to just be a washer so we would advise removing and replacing the copper washer. 3 Hours labour to sort this oil leak and clean the front of the engine where it has leaked onto.

HT leads are old but are working without fail. Signs of a coolant leak from the top radiator hose but has not leaked for a while as the dried coolant has hardened up around the top of the pipe. Some wires are out of factory positioning but that's nothing to worry about.

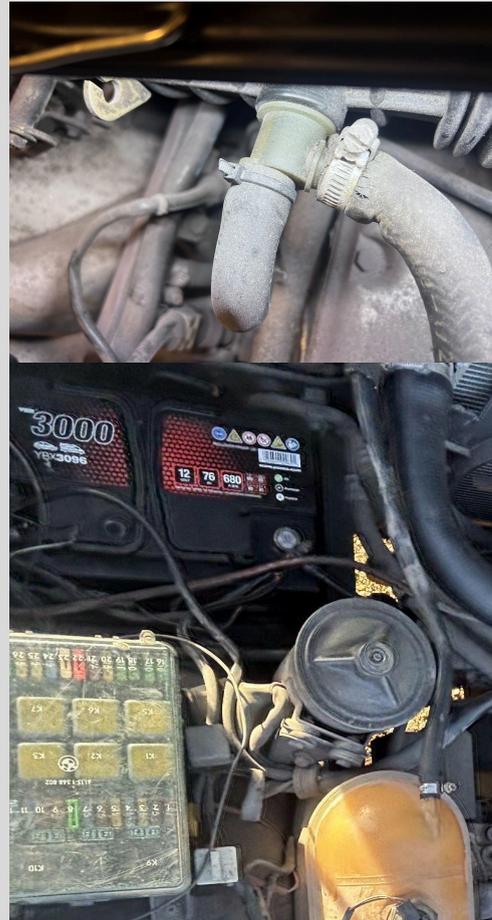
There are areas which require hose clips But there missing and have been replaced With a plastic zip tie, cut at a sharp angle Which is waiting nicely to cut you! This needs to be replaced.

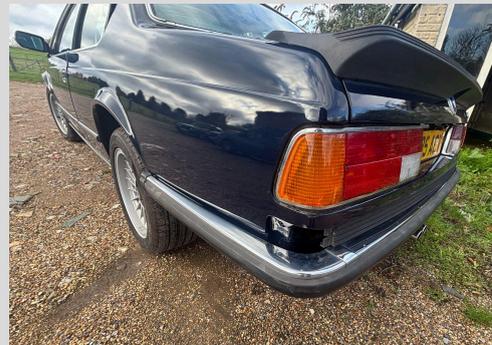
Both rear tail lights are cracked
With the offside rear tail light being
Completely cracked so it may fall off.
Both tail lights should be replaced.
Or at least glued on the offside rear
to avoid the tail light falling out.

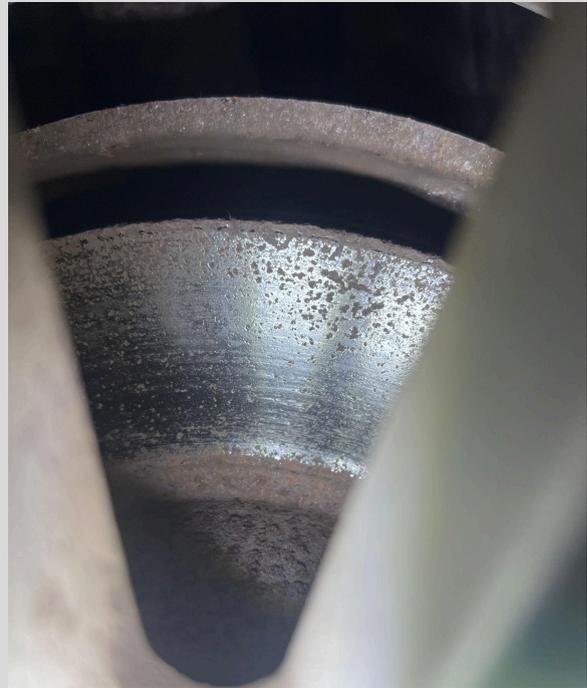
The brake pads themselves have good life left over 50% front and rear. However the discs are very pitted from small amounts of rust that have built up on the disc when its been sitting. Then as the car is used the rust is removed leaving dimples on the disc. Which can be clearly spotted in the photo

This is only an MOT advisory, Ideally discs and pads Should be replaced. 2 hours labour required.

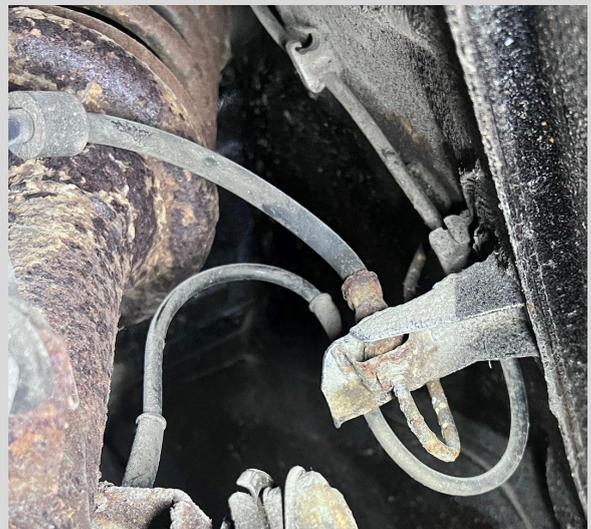
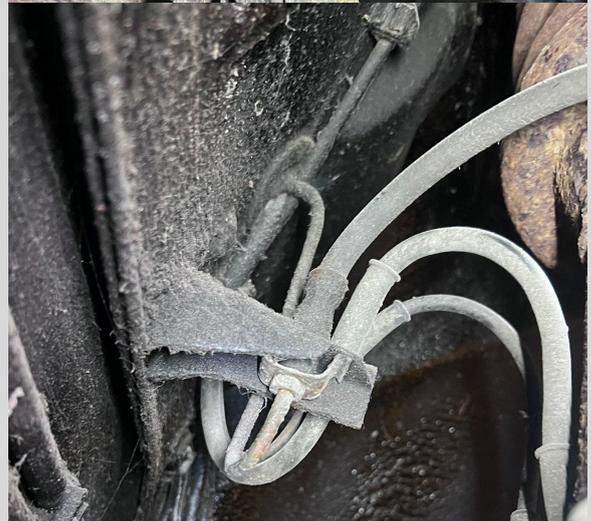
Both are photographed to the right.
NSF Top
OSF Bottom

The nearside front brake pipe has Very slight corrosion and maybe advised on the MOT but it depends how the the tester is feeling that day.

The offside front is in better condition. The hoses on both sides have been replaced and are still holding strong, its only the metal and copper pipe starting to show signs of age.
