Report and Health Check

Mazda MX-5 NB Mk 2 1.8 Soft-top Entry

Declan Lee Motorsport
Unit 3 Fen Place Farm
East Street
Turners Hill
West Sussex
RH104QA

Report Date:
March 23rd 2026

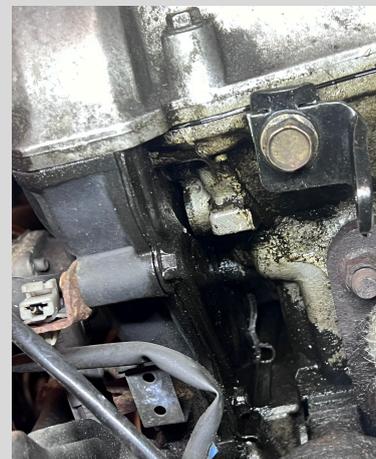
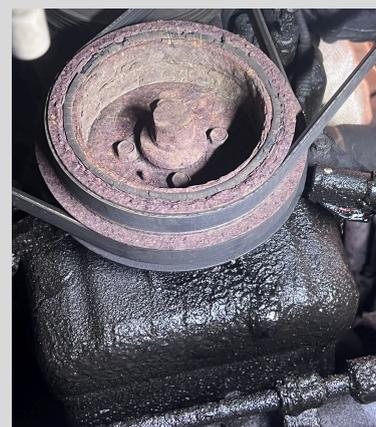
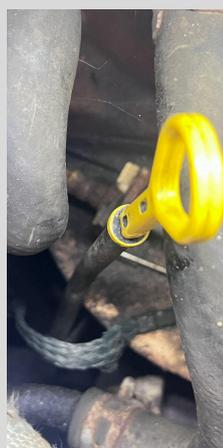
There are several oil leaks present including from the crank seal, rocker cover, and potentially the front cam seal. The oil level is currently extremely low and below the minimum mark on the dipstick which poses a serious risk to engine longevity.

These oil leaks and oil level are photographed to the right.

The harmonic balancer otherwise known as the front crank pulley is heavily corroded and worn, with a risk of failure while driving. This is a priority item for replacement as they are readily available online and are a cheap fix to a problem that could turn much more expensive if it fails.

The oil dipstick is not sitting in the OEM location and is wedged using the ground strap. This is causing an oil leak.

- Coolant Hoses - Not Required - Recommended
- Oil dipstick location - Not Required - Recommended
- Crankseal gasket - Not Required - Recommended
- Rocker cover gasket - Not Required - Recommended
- Harmonic Balancer - Highly Recommended

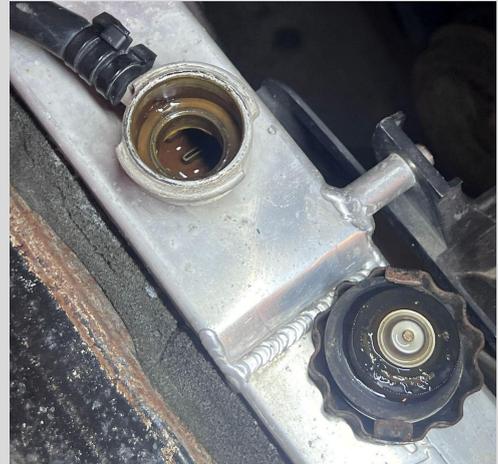
Cooling system components are in poor condition with dry-rotted hoses, low coolant level, and a faulty coolant cap allowing pressure loss. Additionally, the coolant itself is very brown with rust and should be replaced. We discovered the reservoir to the radiator line is held secure using zip ties.

- Coolant - Highly Recommended - In Stock

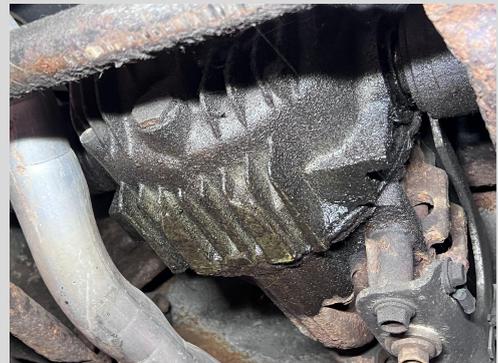
Both rear differential seals are leaking, and there is a risk of differential failure if left unresolved. The differential bushes are worn and cracked, increasing stress on the drivetrain.

- Clutch fluid - Highly Recommended - In Stock
- Gearbox oil - Recommended - In Stock
- Differential oil - Highly Recommended - In Stock
- Differential Seals - Highly Recommended
- Differential Bushes - Not Currently Required - Recommended
- Driveshafts - Not Currently Required - Recommended

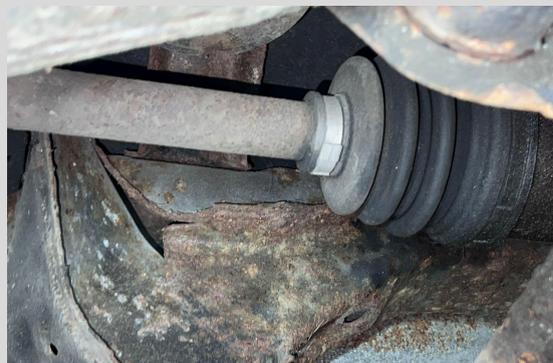
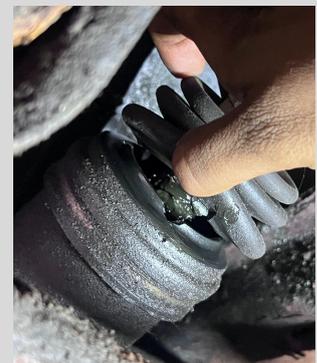
The rear driveshaft boots are split on both sides, which will lead to contamination and eventual failure of the joints.

The gearbox rear seal is also leaking, and the clutch fluid is heavily contaminated and requires replacement.

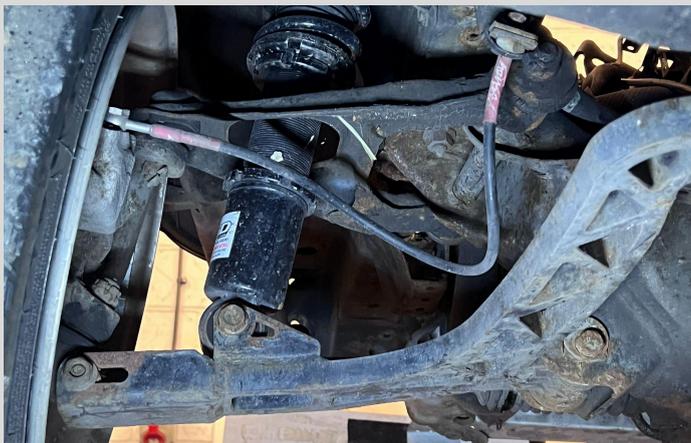
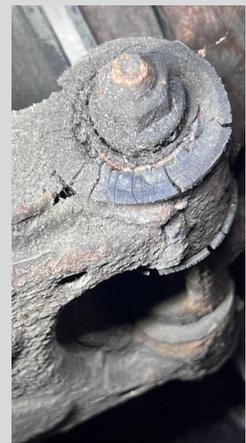
While these provide improved adjustability, several bushes are heavily worn or cracked, particularly on the rear lower suspension and inner front arm mounts.

This wear contributes to instability and can introduce bump steer, especially when driving under British driving conditions.

Ball joint boots are perished on both sides, though there is currently no excessive play.

A full suspension refresh, including bush replacement and alignment, is recommended.

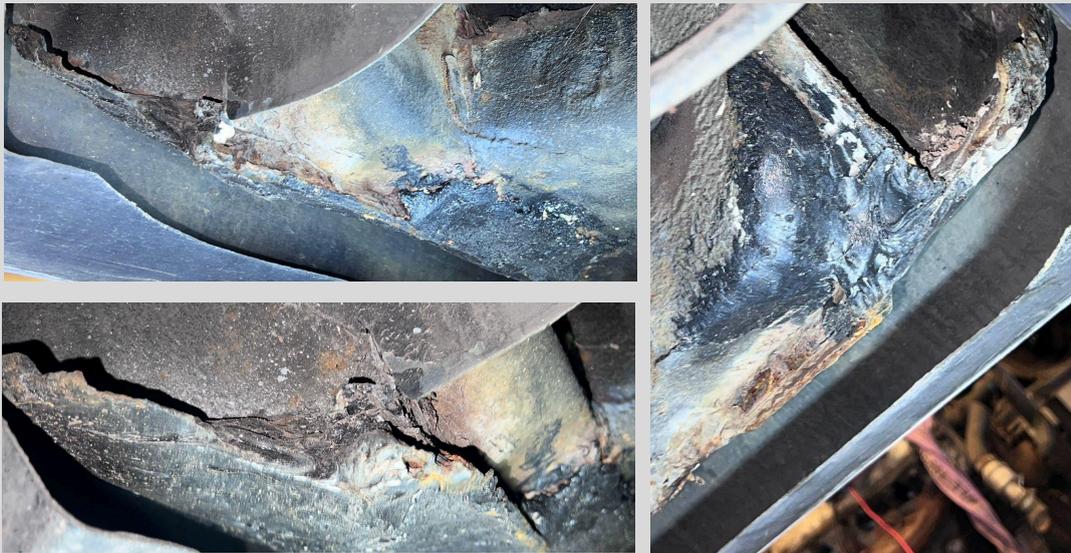
Fiberglass side skirts have been poorly fitted, and the rear sills have been repaired using filler rather than proper metalwork. Areas where expanding foam has been used to fill areas of missing metal. There has been no welding conducted to these sills, only fibreglass based filler then covered in a thick coating of underseal.

This is a cheap form of repair which can hide rust in these areas. This means that the car cannot be jacked up in that area.

- Weld & Repair chassis legs - Highly Recommended - Safety Concern
- Weld & Repair rear sills - Highly Recommended - MOT Concern

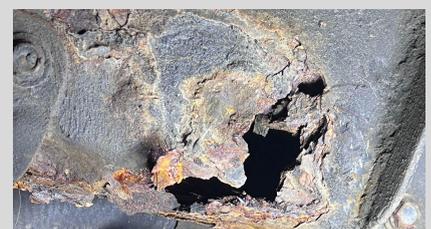
There are critical structural concerns at the front chassis legs, both of which are severely corroded and require immediate welding. These areas are a major safety concern and would not provide adequate protection in a collision, these chassis legs provide the main structure of the MX5.

The repair will require removal of the front subframe, bracing of the engine, and fabrication of reinforced sections; replacement engine mounts are recommended.
